United States
Environmental Protection
Agency

Site Update

San Jacinto River Waste Pits Superfund Site

January 2016

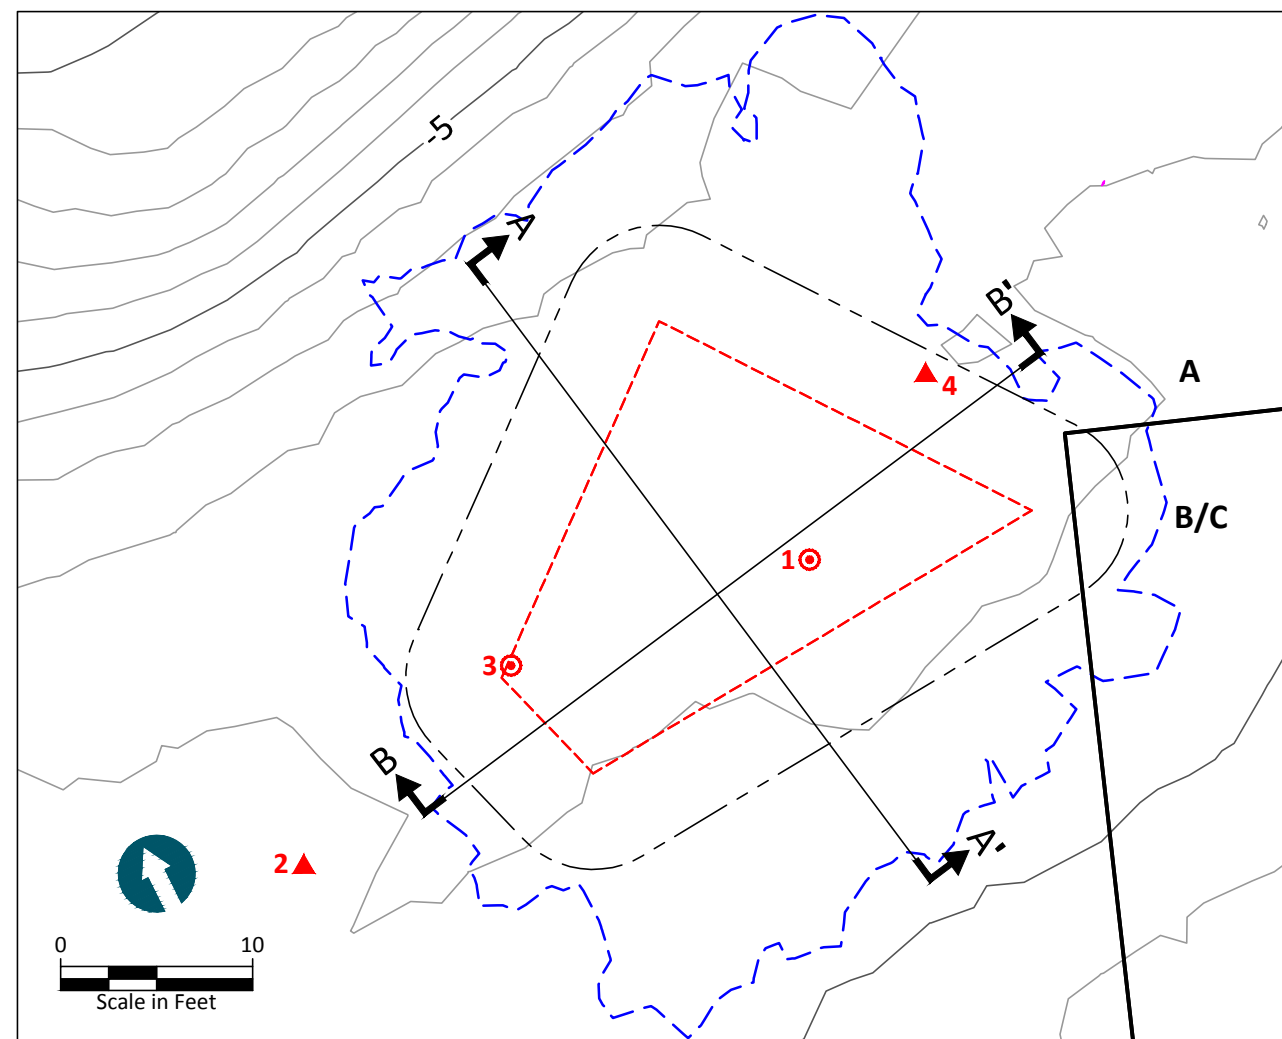
Figure 1 provides details on the repaired area.

As part of the EPA's oversight responsibility, and to verify the condition of the cap, EPA divers completed an underwater inspection of the armored cap on December 10, 2015. The inspection found an area on the northwest part of the cap where the armor cap was deficient. This underwater area does not have a geotextile liner under the rock, and a gap in the armor cap resulted. The EPA directed both International Paper and Industrial Maintenance Corporation, the potentially responsible parties (PRPs) for the San Jacinto River Waste Pits Superfund site (Site) in Harris County, to submit a repair plan for the protective cap. The EPA prescribed that the repair plan should include confirmation sampling to assure the EPA that no materials have been released from the site.

Following EPA approval of the PRP delineation and sampling plan, the PRPs completed work to mark out the length and width of the deficient area, as well as collect sediment samples. The deficient area was irregularly shaped approximately 20-feet by 25-feet in size located under water from 8-inches to 18-inches deep.

Following the EPA's approval of the repair plan, the PRPs completed work to lay a geotextile fabric over the deficient area and cover it with a 1-foot minimum thickness layer of armor rock with an 8-inch median diameter. Manual probing was done to confirm that the minimum rock thickness was achieved, and additional rock was added where needed. Oversight of this work was provided by EPA staff and contractor. Following completion of the work, the PRPs performed underwater survey of the repaired area.

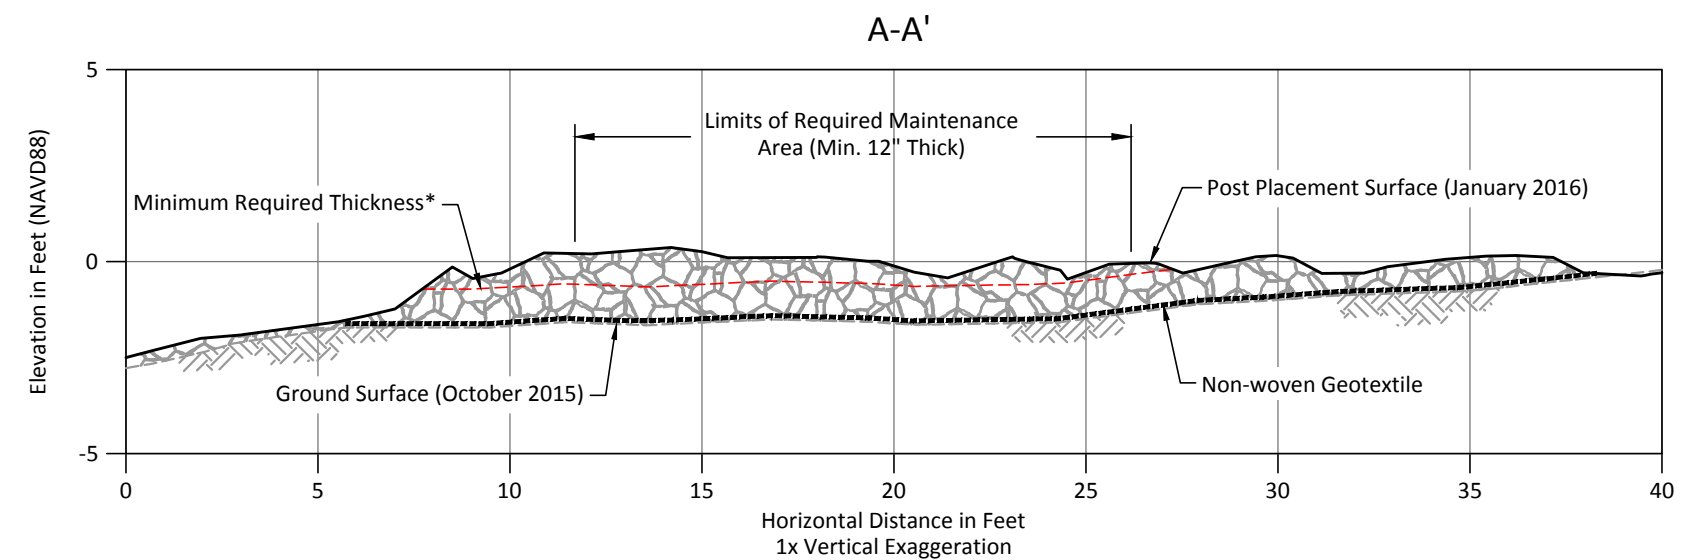
* Minimum thickness was field verified by probing.

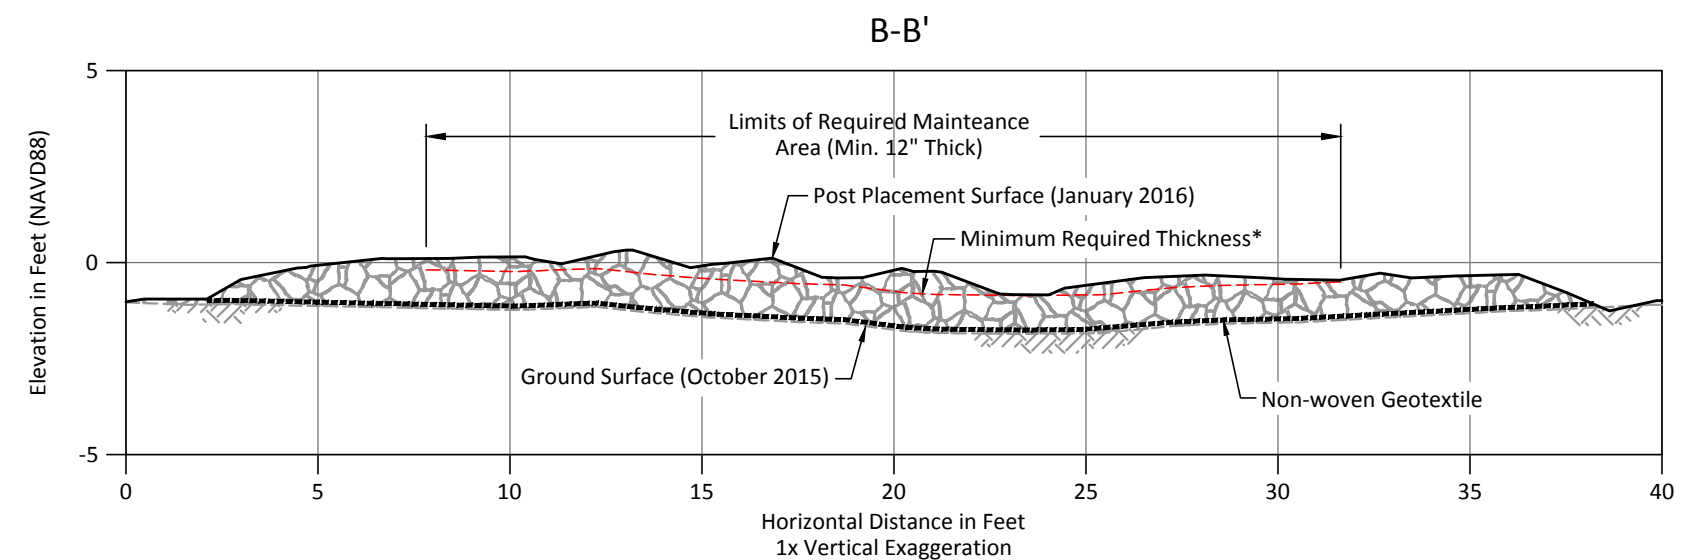
* Minimum thickness was field verified by probing.
